## Preliminary Neighborhood-Scale Seismic Vulnerability Profile Of Residential Buildings In A Selected Urban Settlement In Singaraja Bali Using Fema P-154 Rapid Visual Screening

Indonesia is highly exposed to seismic hazards; however, pre-earthquake neighborhood-scale assessments of residential seismic vulnerability remain limited, particularly in Indonesian urban settlements. This study aims to develop a preliminary neighborhood-scale seismic vulnerability profile of residential buildings in a selected urban settlement in Singaraja, Bali, using the FEMA P-154 Rapid Visual Screening (RVS) method. A total of 120 permanent residential buildings were selected through purposive sampling and assessed using the Level 1 visual screening procedure. The analysis focused on the distribution of RVS scores, estimated probability of collapse, building characteristics, and visual parameters contributing to seismic vulnerability. The results indicate that the final RVS scores ranged from 0.60 to 1.20, with an average score of 1.13, corresponding to an average estimated probability of collapse of 8%. Besides structural type, pounding potential was identified as the dominant visual characteristic,

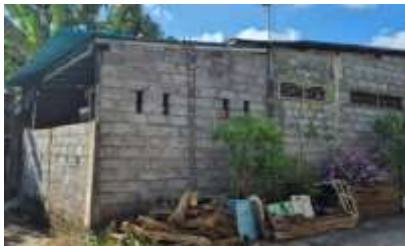
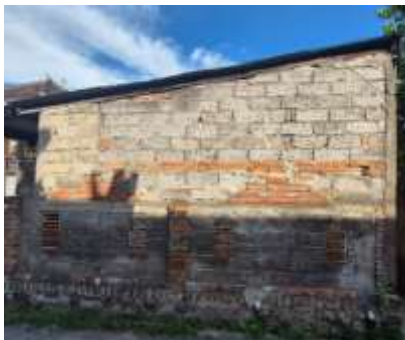
**Figure 3. Representative examples of URM buildings**

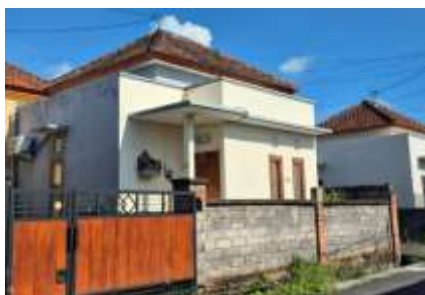
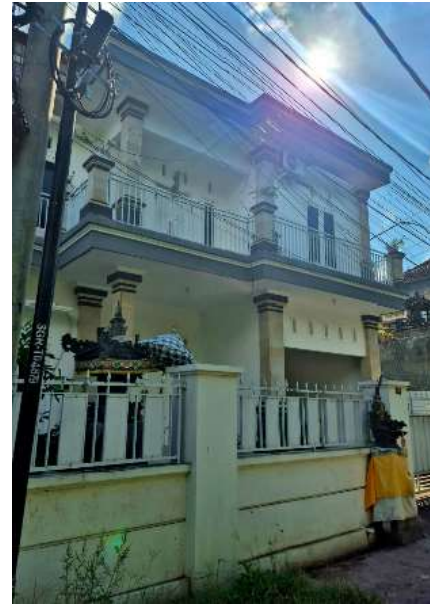
**Figure 4. Representative examples of C3 buildings: (a) 1-story (b) 2-story**

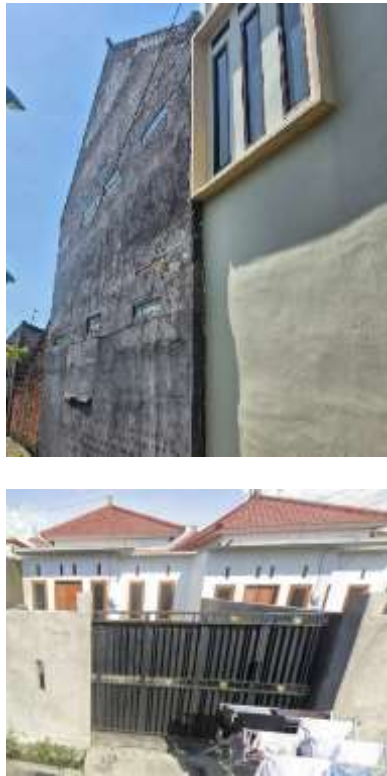
The screening results indicate that pounding potential was the most frequently observed visual characteristic, being identified in 78 of the 120 surveyed buildings (65%). In contrast, plan irregularity was identified in only nine buildings, while no buildings exhibited severe vertical irregularity, moderate vertical irregularity, falling hazards, geological hazards, or visible structural deterioration.

The predominance of pounding potential is likely associated with the characteristics of urban residential development in the study area, where relatively high building density and limited separation distances between adjacent houses are common. Field observations showed that many residential buildings were constructed with minimal spacing, and several were arranged in configurations that could permit structural interaction during strong earthquake shaking. Such conditions were observed not only in incrementally developed self-built residential areas but also in planned housing clusters characterized by relatively

**Figure 6. Representative examples of adjacent residential buildings exhibiting pounding potential due to insufficient separation distance**

Within the context of this study, however, the presence of pounding potential was not interpreted as an additional criterion for recommending Detailed Seismic Evaluation. Instead, it was considered an important characteristic for describing the dominant seismic vulnerability profile of the investigated residential neighborhood. This finding suggests that, in addition to structural type and building configuration, the overall neighborhood vulnerability profile is also influenced by urban development patterns that result in relatively small separation distances between adjacent residential buildings.
