## Service Capability In Meeting Irrigation Water Availability At Cengklik Reservoir

*Cengklik Reservoir, located in Boyolali Regency, is mainly used to supply water for irrigation. However, changes in hydrological conditions and increasing irrigation water demand have created an imbalance between available water and irrigation needs. This study aims to evaluate the reservoir's ability to meet irrigation water demand and assess the performance of the irrigation network. The F.J. Mock method was used to estimate the dependable discharge, which had an average value of 0.338 m<sup>3</sup>/s. In addition, water from the Watuleter Supplementary Supply was considered as an extra source, providing an average discharge of 0.296 m<sup>3</sup>/s. The irrigation system serves an area of 1,460 ha with a rice-rice-secondary crop planting pattern, requiring an average irrigation water demand of 1.239 m<sup>3</sup>/s. The water balance analysis showed a surplus during seven periods, although water deficits still occurred in the remaining periods. The recommended alternative was to change the planting pattern to rice-secondary crop-secondary crop, which increased the number of surplus periods to

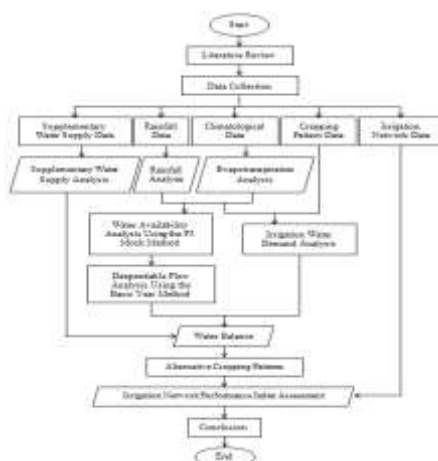
**Figure 1. Research Flowchart**

This study involves several analyses and methods, as illustrated in the flowchart. The data processing steps are described as follows:
